## KIRK N. ELLIS & ASSOCIATES STRUCTURAL & CIVIL ENGINEERING, LTD.

**PROJECT:** Vicks Residence

**LOCATION:** 2445 Faretto Lane, Reno, NV

### Report Date: 02/10/2010

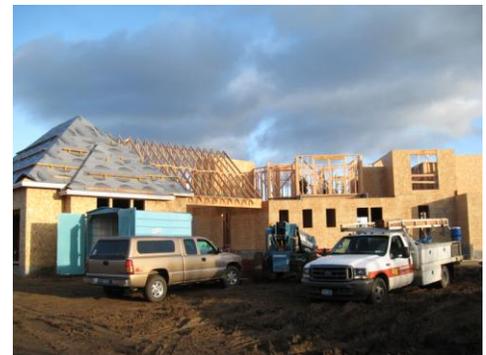
1. The basement and first floor appeared to have been completely framed and progress was being made to complete construction on the second floor. See Figure

FIGURE 1 – PROGRESS OF STRUCTURE.

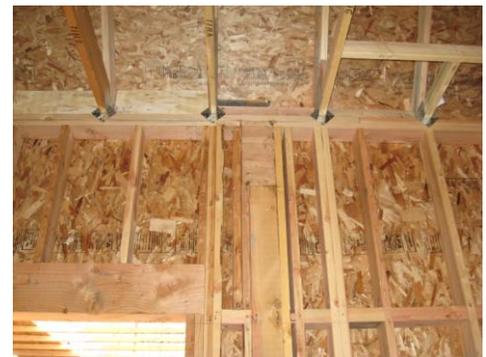
2. The Simpson H1 Hurricane ties that were previously mentioned in the Field Report dated 01/07/2010 are still installed on the interior face of the garage. See Figure 2. This is contrary to the structural drawings. Refer to detail 1/S4.3. The H1 is ineffective on the interior face of the structure unless the (2) 2x6 top plates are also connected directly to the studs adjacent to the connection point. If the contractor wishes to continue connecting the H1's to the interior, he will need to request a change and additional hardware will be required.

FIGURE 2 – H1 HURRICANE STRAPS INSTALLED ON THE INTERIOR FACE OF WALL.

As previously mentioned in the Field Report dated 01/07/2010, the Simpson H1 Hurricane Ties that connect the Pre-Manufactured Wood Roof Trusses to the double top plate are not installed on the exterior face of the structure as specified in

KNE detail 1/S4.3. This renders the specified connection deficient as it changes the failure point to a very weak spot. The original design intent is to engage the sheathing, and therefore the entire shear wall, with the load imparted by the wind uplift. These loads then would be transferred into the footing and equalized. By relocating the hurricane tie to the interior of the structure, opposite the side of the stud that is sheathed, the uplift force is no longer transferred into the studs or even the sheathing. The uplift force works on the double top plates and, without any sufficient connection from the top plates to the studs, may cause a premature failure in the double top plates. If Wasik Construction intends to leave the H1's on the interior of the structure, mechanical connections that tie the top plates to the studs would be required, i.e. SP2 or similar every stud to the top plates. Once the full capacity of the stud is engaged, the sheathing in turn will be engaged and the shearwall can then properly resist the calculated wind uplift forces.

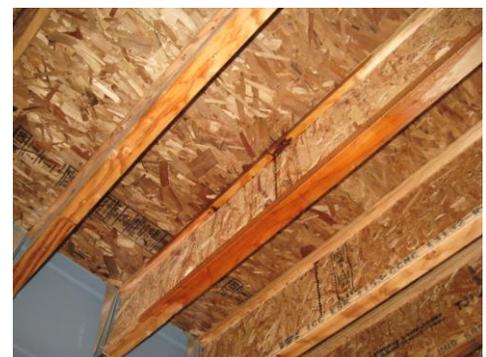
3. The first floor appeared to be fully sheathed and nailing appears to be in compliance with structural plans and specifications.
4. The first floor sheathing had been painted to prevent further water damage. While this can be an effective method of moisture mitigation, not all nooks and crannies were sealed. The TJI's below have experienced some water exposure. See Figure 3. TJI's are made of an engineered material that is not designed for prolonged

FIGURE 3 – WATER ON TJI'S

moisture exposure. Please verify with supplier that manufacturer's warranty is still valid.

The TJI's and Pre-Manufactured Wood Roof trusses are designed and engineered by a third party. Typically, neither of these systems can sustain extended exposure to moisture or fractures in designed members. The TJI's in the first floor have experienced several winter storms. It appears that Wasik attempted to "seal" the floor sheathing to protect the sheathing and underlying structural components from prolonged moisture. This method appears to have been mostly successful. There are a few locations where the latex paint was not enough to inhibit moisture movement. The manufacturer(s) should be contacted to conduct an inspection of their product and suggest any repairs if required. The Pre-Manufactured Wood Roof Truss manufacturer should also be contacted about the fracture in the top chord of their girder truss. They should either provide KNE with a revised calculation indicating this fractured member is sufficient for the load imparted, or with a "wet-stamped" repair calculation.

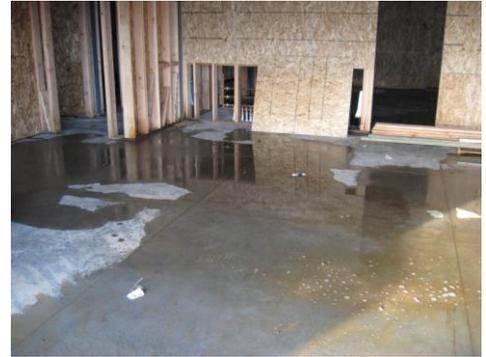
5. The water leaking down through the painted floor sheathing above revealed that there may be a floor slab levelness issue with the garage slab below. There is some pooling (as deep as  $\frac{3}{4}$  to 1-inch) in the center of the slab. See Figure 4.
6. Sheathing panel blocking has been installed per structural plans. Most full height walls have the appropriate plate breaks per structural plans. See Figure 5. There is one section, however at the stair well that full height studs were used with no plate break provided. See Figure 6.
7. One of pre-manufacture wood roof trusses has been damaged on at least one ply. See Figure 7.

FIGURE 4 – WATER POOLING AT CENTER OF SLAB.

The garage slab is not exactly even or level. There was significant ponding in the garage with water depths at up to approximately  $\frac{3}{4}$  to 1-inch. This area should experience little or no exterior exposure and the ponding is not a problem structurally, but might be a concern for the owner. The owner may wish to investigate this further.

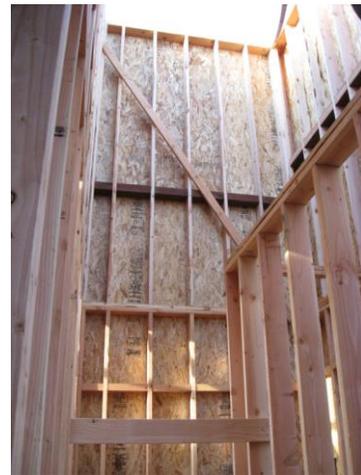
FIGURE 5 – FULL HEIGHT WALL STUDS WITH PLATE BREAK AND BLOCKING.

At most locations, the structural details, in regard to full height studs, are being followed. It is necessary for all studs to be broken at the floor level and a double top plate installed at the joint. This allows the double plates to act as a wind beam for pressure or suction perpendicular to the plane of the wall. When a stud is run full height with no additional support from a double plate wind beam, it doubles the load on the stud and dramatically increases the deflection and bending the stud endures. While it is true that the stair landing may be designed to brace the surrounding stair walls, the total length of unbraced studs exceeds original design calculations. **Please advise KNE if a redesign review is to be performed, or if Wasik construction wants to reconstruct the aforementioned walls.**

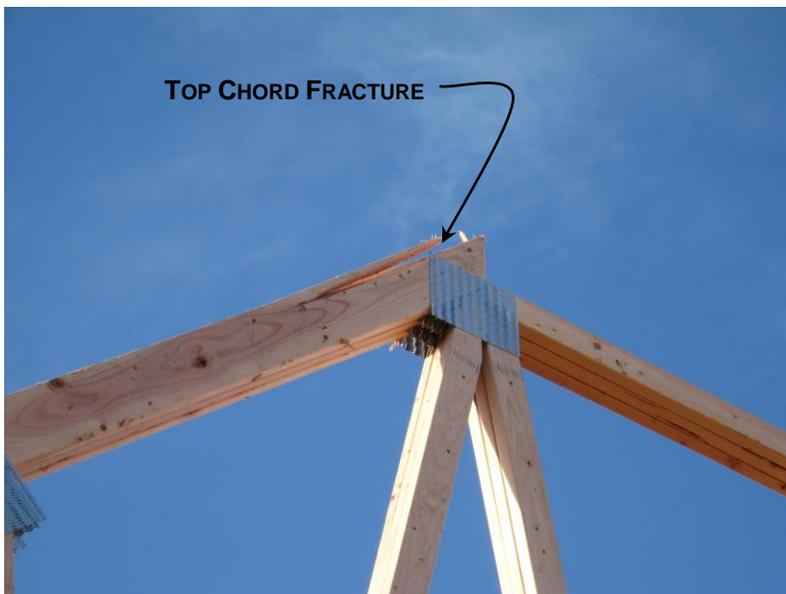
FIGURE 7 – PRE-MANUFACTURE WOOD ROOF TRUSSES WITH DAMAGE.

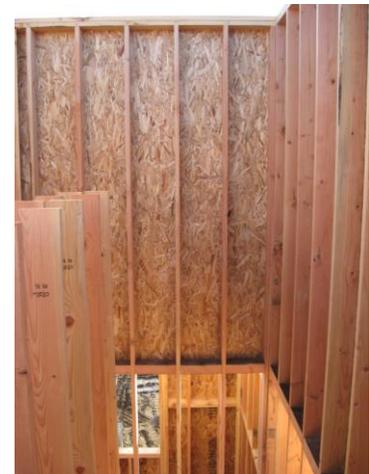
FIGURE 6 – FULL HEIGHT STUDS WITH BLOCKING AND NO PLATE BREAKS.
