KIRK N. ELLIS & ASSOCIATES
STRUCTURAL & CIVIL ENGINEERING, LTD.

DATE: 01/29/2010	JOB #: 0410
PROJECT: RHA Residential Inspection	
LOCATION: 12060 Camel Rock	
CONTRACTOR:	
OWNER: Reno Housing Authority	
WEATHER: Overcast	
TEMP: 34°F	TIME: 8:00am
PRESENT AT SITE:	
Brian Wilcox – Kirk N. Ellis & Associates	
Kirk N. Ellis – Kirk N. Ellis & Associates

At the request of Tim O'Fallon of the Reno Housing Authority, this office went to conduct an Initial Structural Engineering Visual Inspection Site Visit for the residence located at 12060 Camel Rock Drive, Reno, Nevada. This residence is identified by the Washoe County Assessor as APN: 550-081-18, and listed as a Two Story, Single Family Residence built about 1997.

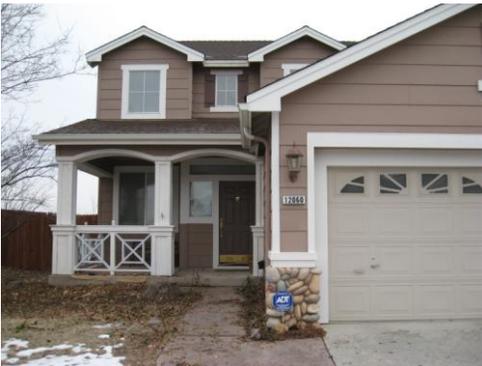
1. The exterior of the structure is finished with horizontal lap siding. See Figure 1. The exterior face of the structure is experiencing some movement. There are many nails that are loose or are in elongated holes.

FIG. 1: EXTERIOR OF RESIDENCE

The residence showed no evidence of stiff or racked door openings or stiff operation or racked window openings. However, many of the doors and windows were available for inspection due to preparations for painting. There was no indication of racked openings. No compression bulges were visible, and no diagonal tension cracks were seen. The recent touch-up work and painting that had been performed might cover up any cracks, therefore, this inspection method cannot be as effectively applied. The exterior sheathing panel nails are working in some kind of movement. The nails are working their way loose, and at some locations, are elongating the original holes the nails were placed in. The nails in pull-out should be removed and replaced with wood screws or screw-nails.

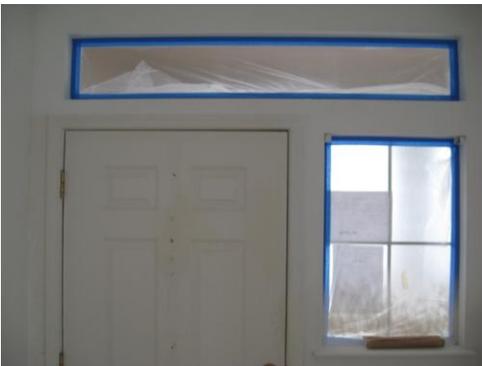
4. Very few of the exterior doors and windows were available for inspection. Most of the residence had been prepared for painting. See Figure 2. Of the few openings that were available for inspection, no stiff or racked openings were observed.

FIG. 2: OPENINGS PREPARED FOR PAINTING, WITH PLASTIC SHEETING.

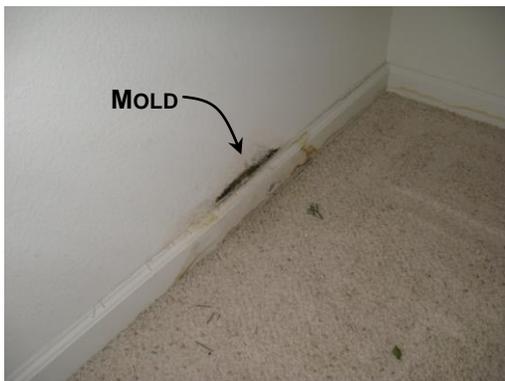
5. Inspection of the storage closet under the stairs revealed a potential health safety problem. Black mold stain exists at a location that appears to have been wet for a long period of time.

See Figure 3. Inspection of the crawlspace directly below revealed an array of water pipes and an additional location of mold or wood rot. See Figure 4.

FIG. 3: APPARENT BLACK MOLD AT WATER SPOT

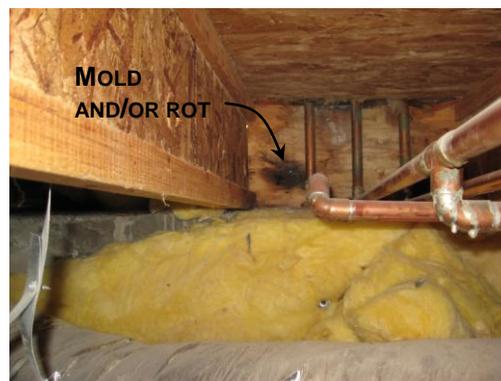
FIG. 4: ADDITIONAL MINOR WATER DAMAGE AND POSSIBLE MOLD.

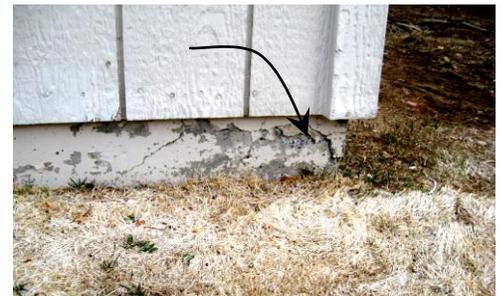
8. The exterior side of the stem wall was available for inspection for only the top 6-inches. Most of the stem wall seemed in good repair with only typical and minor drying shrinkage cracks. One corner was not typical and showed signs of excessive concrete degradation. See Figure 5. Chipping, followed by epoxy/mortar repairs are recommended.

FIG. 5: CONCRETE DEGRADATION.

The concrete footing and stem wall was open for inspection at a few locations from the interior crawlspace and only the top six inches from the exterior of the structure. The concrete showed no signs of excessive weathering, efflorescence, spalling or failure cracks or fractures on the interior. Concrete drying shrinkage and temperature cracks exist, but are well within expected limits. On the exterior of the structure, at the south-east corner (See Figure 5), however, there was one section of weak concrete. This concrete should be chipped away and the adjacent structural members exposed. It is important to find out if this concrete failure is systemic or just localized.

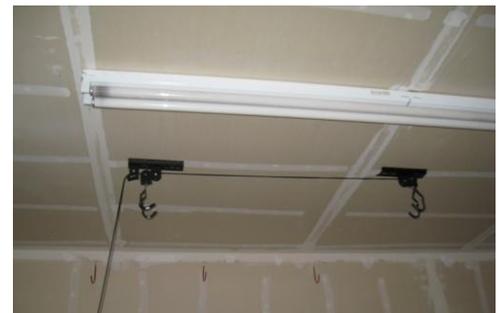
10. There are several ceiling mounted lift or hangers. See Figure 6. This is a common mistake of homeowners. Roof trusses and floor joists are almost never designed to carry these additional dead loads. The areas directly above these locations were not available for inspection.

FIG. 6: CEILING MOUNTED LIFT HOOKS

In the garage, there are several "hooks" and "ceiling shelves". Often times, home owners will install these types of mechanisms thinking that the structure above will "more than handle" the load they are imparting. This is simply not true. Most structures are designed for maximum normal loads. This can include roofing materials, snow and wind loads as well as mechanical and electrical equipment. Rarely, if ever, are these members designed for lumber storage or engine blocks. Unfortunately, the areas that would be affected by the additional loads, and possibly structural failures, are not accessible. It is strongly encouraged that this be further investigated. The finish materials should be removed and the structural members assessed. Drilling into truss members is not advised.

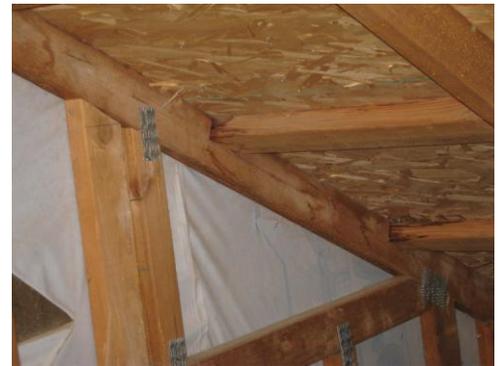
FIG. 7: WATER DAMAGE AT OUTLOOKERS.

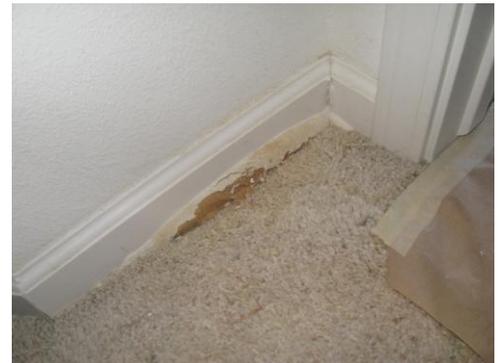
FIG. 8: WATER DAMAGE AT BASEBOARD.

The residence also had another spot that might need to be subject to further investigation. The base board in Figure 8 seems to have been exposed to prolonged moisture. The carpet and pad in this area should be "pulled-back", and the floor sheathing should be inspected for mold, rot or other water damage. If water damage is observed, the sheathing should be evaluated. The floor joists might also need to be inspected for additional water damage.
